7.0 Green River, Utah, Disposal Site

7.1 Compliance Summary

The Green River, Utah, Disposal Site, inspected on March 8, 2007, was in excellent condition. Unnecessary groundwater monitoring wells were decommissioned and telemetry systems were installed in several wells during 2007. Groundwater monitoring continued for the purpose of evaluating cell performance; no constituents of concern exceed their respective proposed alternate concentration limits. No cause for a follow-up or contingency inspection was identified.

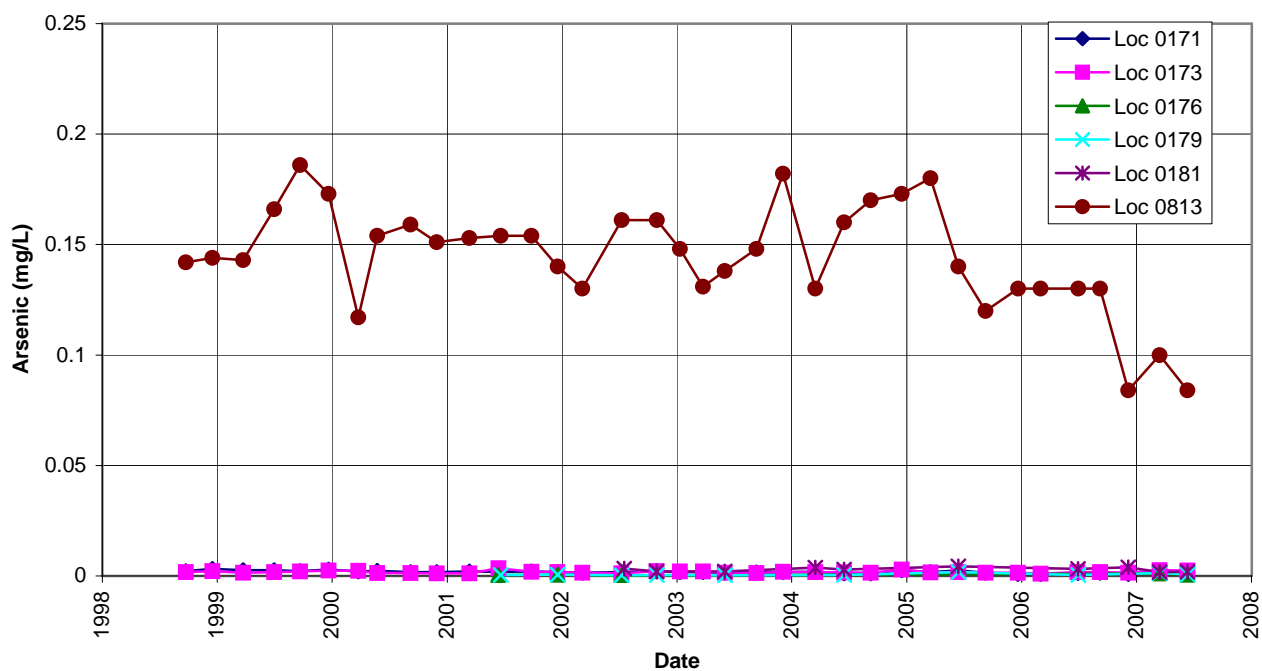
Figure 7-2. Time-Concentration Plots of Arsenic in Groundwater at the Green River, Utah, Disposal Site

Arsenic concentrations in groundwater remain below the MCL of 0.05 mg/L in all POC wells except MW-0813, and considerably below the proposed ACL of 5.0 mg/L in all POC wells. In well MW-0813, levels have exceeded the MCL over the entire sampling period (Figure 7-2) but are substantially below the proposed ACL. The results for this well indicate an apparent downward trend in the last few years.

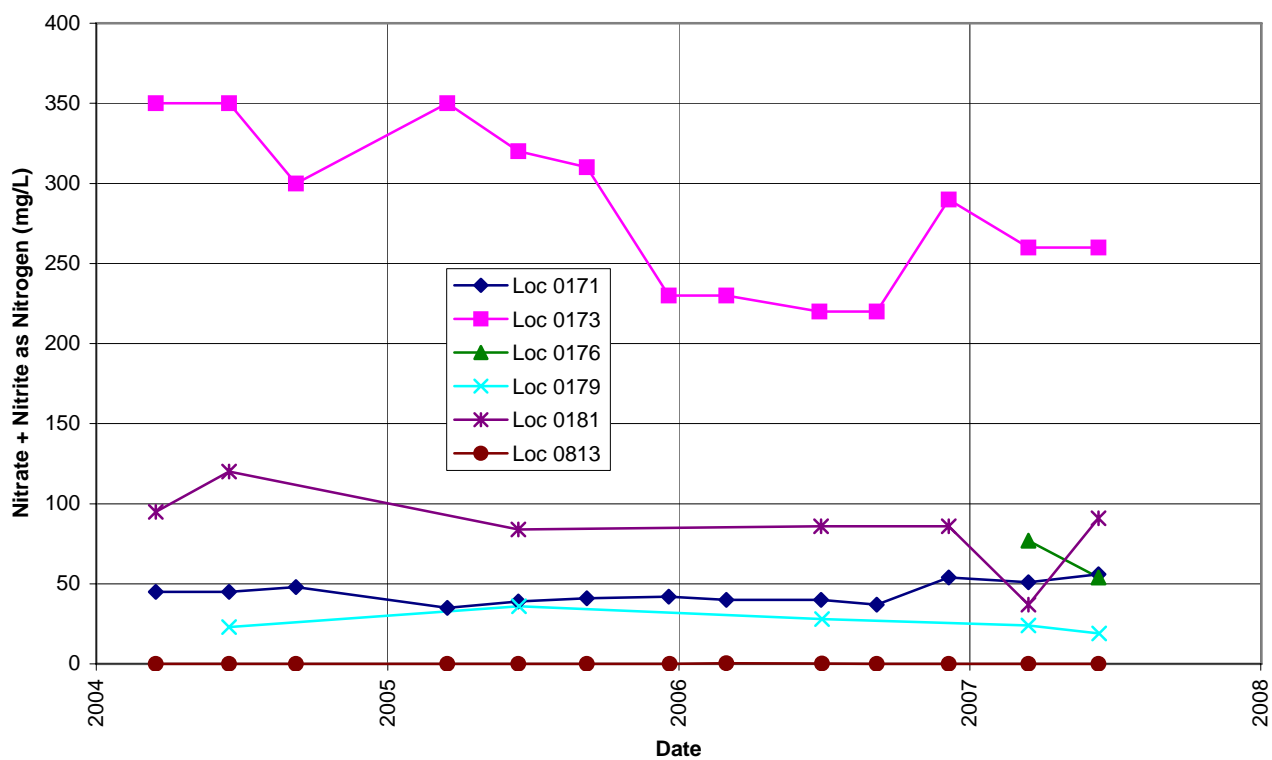
Figure 7-3. Time-Concentration Plots of Nitrate in Groundwater at the Green River, Utah, Disposal Site

Nitrate concentrations have been measured as nitrate plus nitrite as nitrogen since early 2004 (prior to that time, nitrate was measured as NO₃). Concentrations have continued above the MCL of 10 mg/L in all POC wells except MW-0813, but are considerably below the proposed ACL of 1,000 mg/L in all wells; values for MW-0813 continue near the laboratory detection limit (Figure 7-3). An overall downward trend has been occurring in well MW-0173, and an apparent slight upward trend is occurring in well MW-0171.

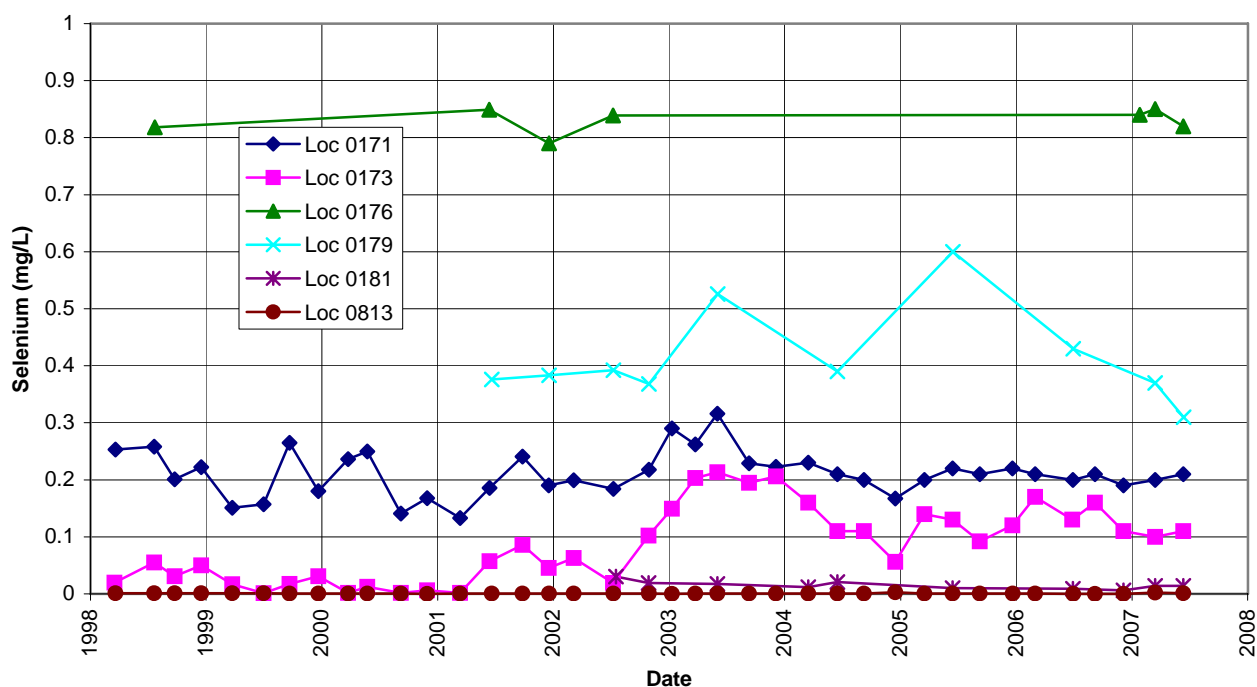
Figure 7-4. Time-Concentration Plots of Selenium in Groundwater at the Green River, Utah, Disposal Site

Except for well MW-0813, which remains near the laboratory detection limit, selenium concentrations in groundwater continued above the MCL of 0.01 mg/L but below the proposed ACL of 1.0 mg/L in the POC wells (Figure 7-4). Selenium concentrations have been decreasing in well MW-0179 for the past two years; otherwise, no trends are apparent in the POC wells.

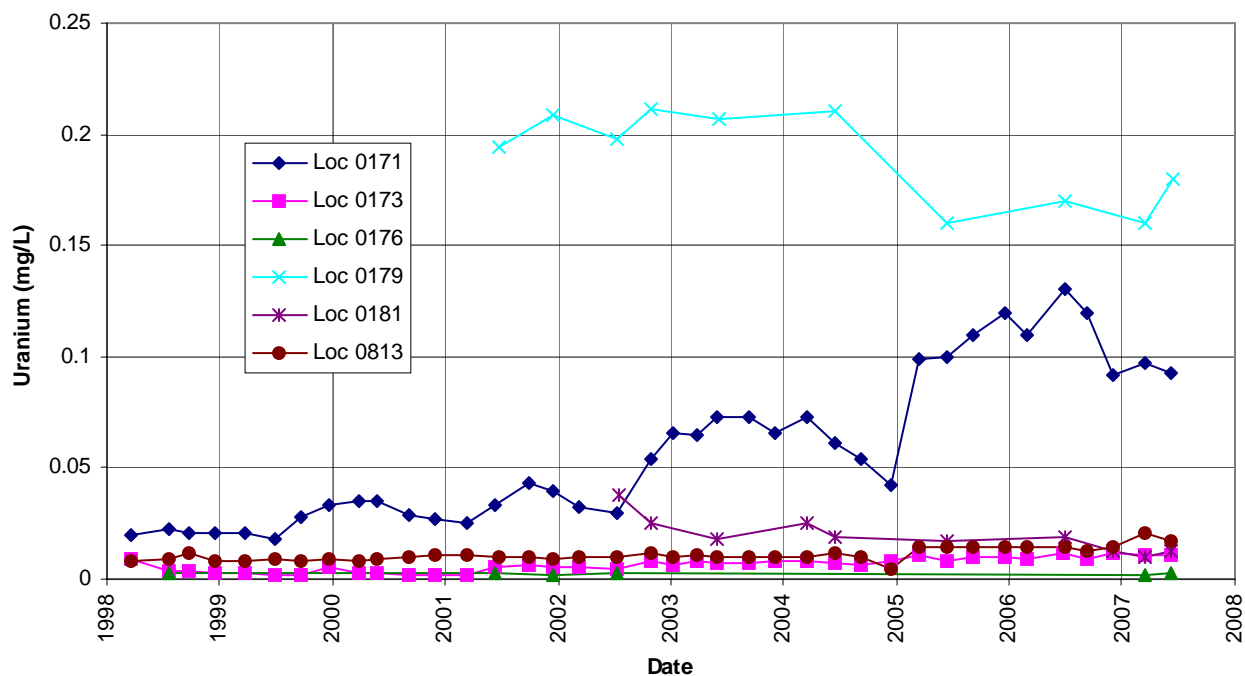
Figure 7-5. Time-Concentration Plots of Uranium in Groundwater at the Green River, Utah, Disposal Site

Uranium concentrations in groundwater remain below the MCL of 0.044 mg/L and considerably below the proposed ACL of 4.4 mg/L, and continue to remain essentially constant in wells MW-0173, MW-0176, MW-0181, and MW-0813. The highest uranium concentrations continue to occur at well MW-0179, which is apparently upgradient from the disposal cell; the cause of the elevated concentrations has not been determined. At well MW-0171, concentrations exceed the MCL and continue to exhibit an overall upward trend even though the last three measurements have been less than its peak concentration (Figure 7-5). Because uranium is the only constituent of concern in well MW-0171 that has indicated an upward trend, no conclusions regarding the cause of the trend have been reached at this time.

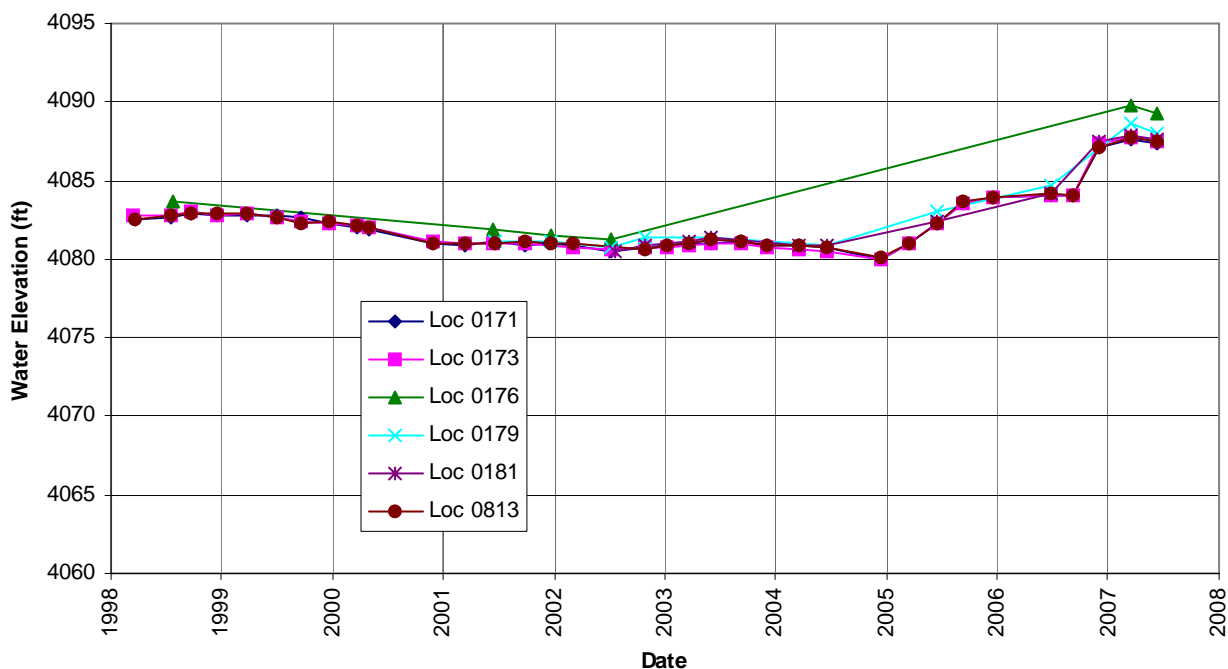
Figure 7-6. Groundwater Elevations at the Green River, Utah, Disposal Site

Water level hydrographs of the POC wells, completed in the Middle Sandstone Unit of the Cedar Mountain Formation, indicate that an overall decrease in the groundwater elevation of approximately 2 feet occurred from 1998 through 2004, followed by an increase of approximately 8 feet since then (Figure 7-6). This rapid increase in groundwater elevation adjacent to the cell may be the result of local recharge. Numerous heavy rainfall events have occurred at the site in the last couple of years and, apparently, runoff from the disposal cell slopes has pooled in the apron trench and then seeped downward through vertical fractures in the Cedar Mountain Formation and into the Middle Sandstone Unit aquifer. Erroneous manual measurements, likely due to equipment problems, occurred on several occasions (continuous measurements indicated essentially no change at those times); these measurements are not shown on Figure 7-6.

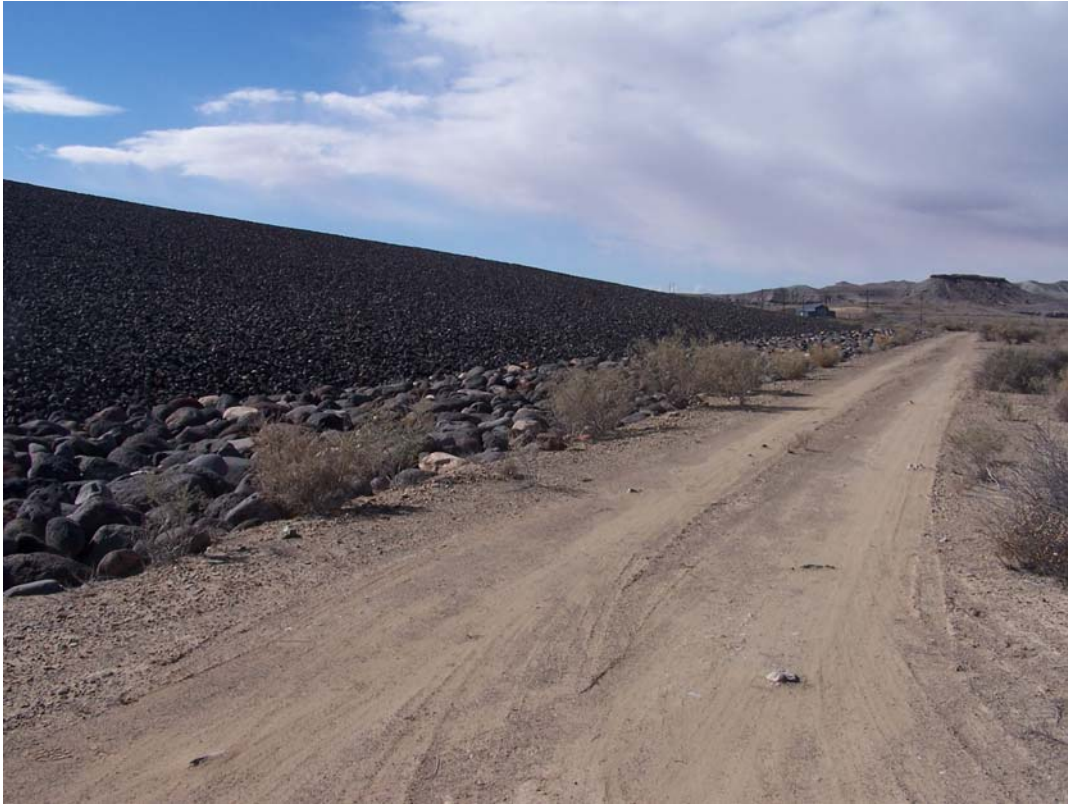
Disposal Cell and Adjacent Area Inside the Security Fence—The 6-acre disposal cell was completed in 1989. The slopes of the disposal cell cover are armored with basalt rock. The cell cover was in excellent condition. The riprap-filled apron trench along the base of the disposal cell on all sides was in excellent condition (PL-1).

GRN 3/2007. PL-1. Perimeter road along the disposal cell apron.

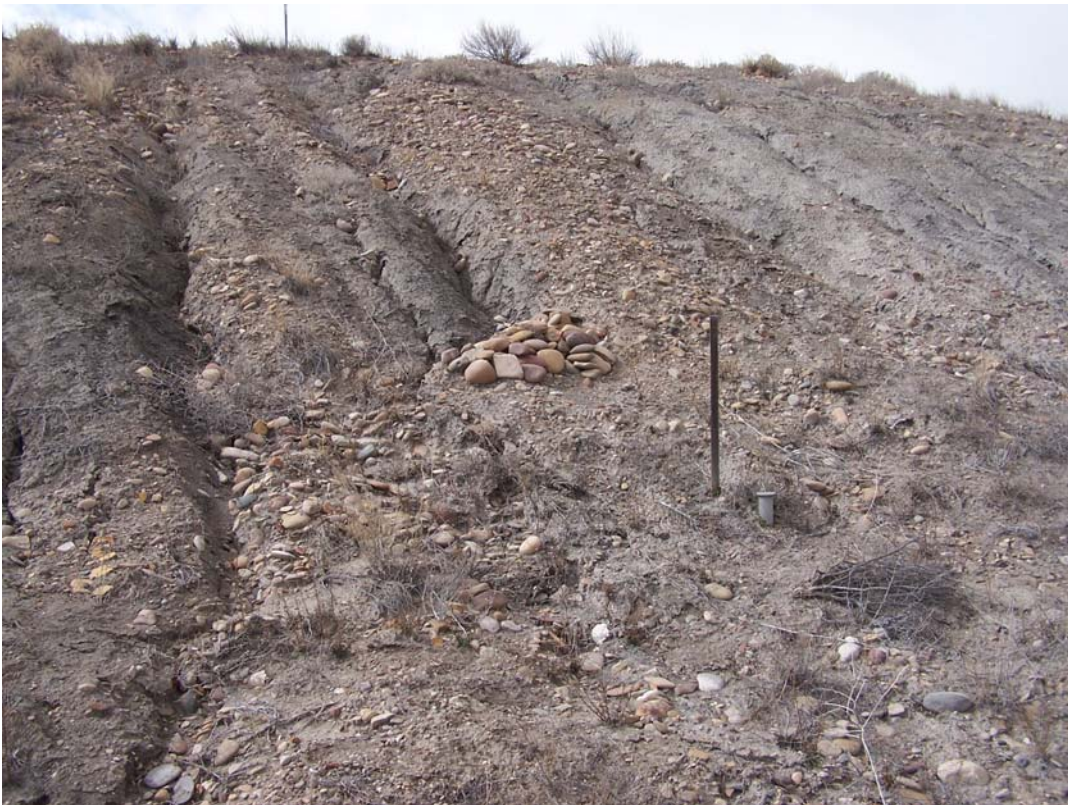
Site Perimeter Between the Security Fence and the Site Boundary—Rills and gullies are present on the west side of the property but do not pose a threat to the integrity of the cell and currently are not impacting any site surveillance features. Rills and gullies are also present along the escarpment northeast of the disposal cell in the area between boundary monument BM-7 and survey monument SM-3 (PL-2). Maximum gully depth in this area is approximately 3 feet. The rill and gully erosion poses no threat to the integrity of the disposal cell but could eventually damage perimeter signs and boundary monuments.

GRN 3/2007. PL-2. Gullies and rills near boundary monument BM-7.

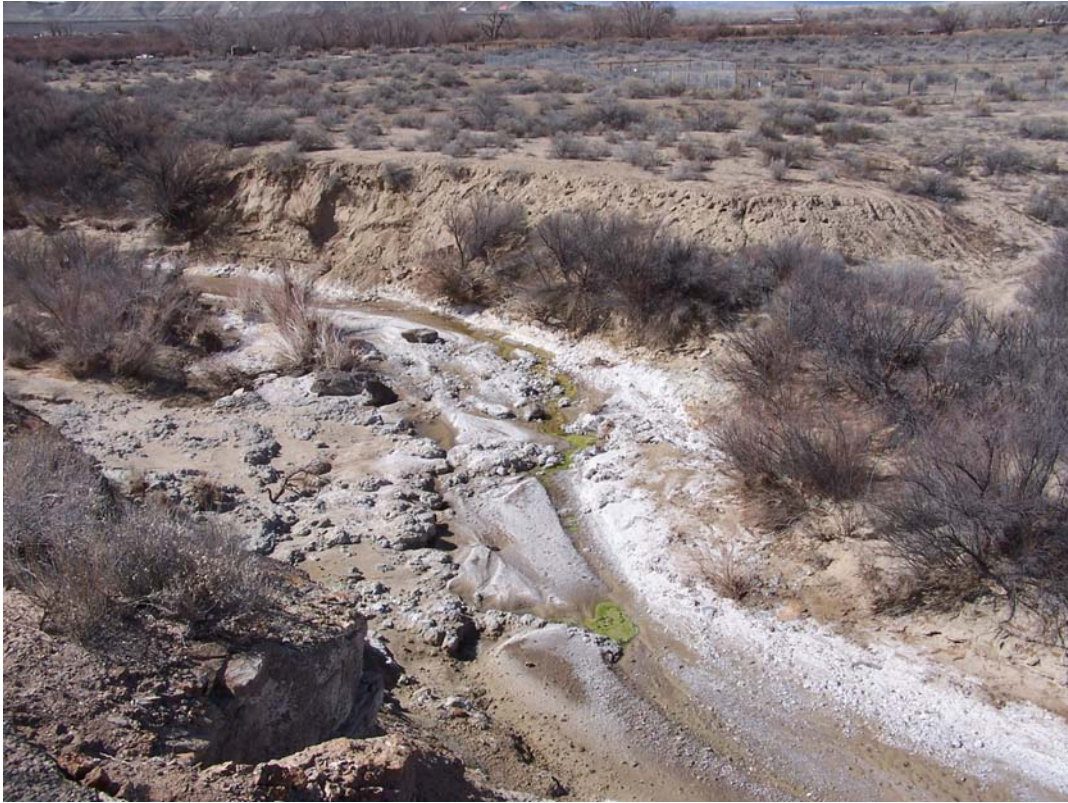
The alluvium in the bottom of Browns Wash was moist, and very small pools were present at several seep locations at the time of the annual inspection (PL-3). These seeps have been identified as potential discharge locations for the contaminated Middle Sandstone Unit aquifer of the Cedar Mountain Formation (the aquifer is contaminated under the disposal site from former processing site operations and disposal cell construction). Extensive field observations indicate that many of the small ephemeral pools in Browns Wash are the result of recent runoff in the wash and dewatering of the alluvium. However, observations during sub-freezing temperatures in January and February 2007 indicated slight but steady flows at several documented seep locations. The warm water, presence of green algae at these locations, and poor water quality suggests that the seep water is derived from vertical fractures emanating from deeper aquifers such as the Jurassic Morrison Formation (the Middle Sandstone Unit is not present under the principal seep at location 0718). Most of the seep locations were dry when the site was visited in September 2007.

GRN 3/2007. PL-3. Browns Wash seep 0718 at the main Cedar Mountain Formation outcrop area.

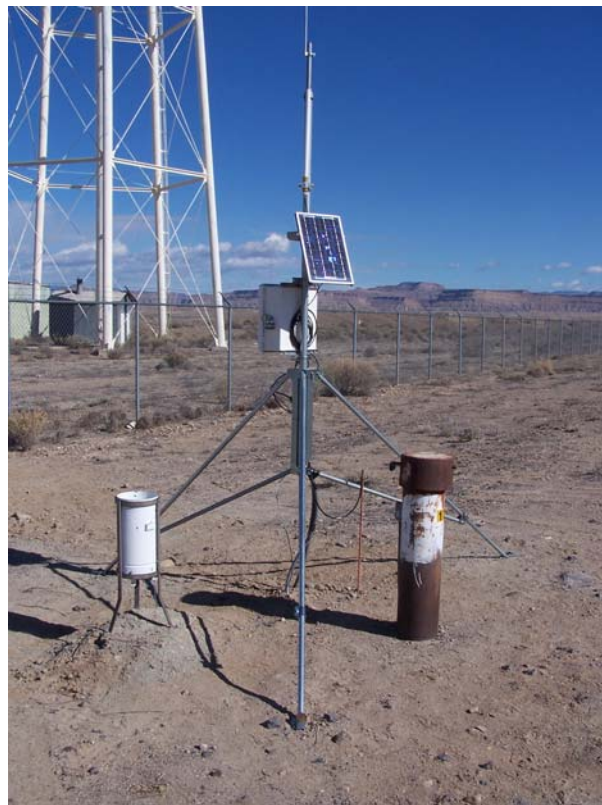
GRN 3/2007. PL-4. Telemetry tower and precipitation gauge at monitor well MW-0171.
